## TEST REPORT VIBRATION TEST

doc: ug-crate vibration  
data: 11/02/087  
rev: A01  
pag: 1 di 15  
file: VIBRPT55-S1105C-A01-11LUG2K8.doc

CUSTOMER: G&A Engineering - Orticola (AQ) - Italy - phone: +39.0863.90.90.03

Job Number: .....**S1105C**  
Universal test number: ..**VIBTEST55**  
Test performed on: UG CRATE FM (flight module)

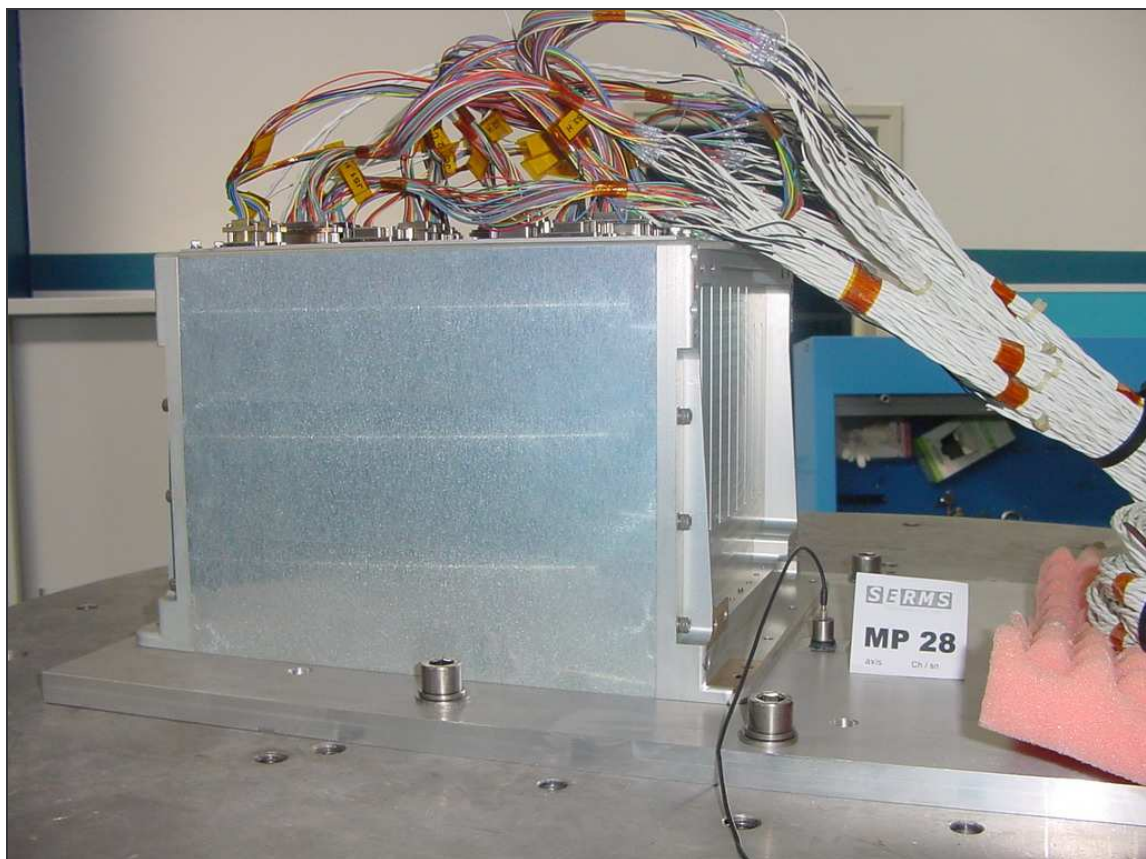
The general view of the test setup for the Z-axis is shown in figure 1. For the Z-axis sub-test the **DUT** has been mounted on a fixture matching the Z-axis of the DUT with the slip table axis, as shown below. Many sensors (channels or CH) have been used during this sub-test. They were fixed on the DUT by cyanoacrylic glue.

**FIGURE 1: Z-Axis test set-up.**

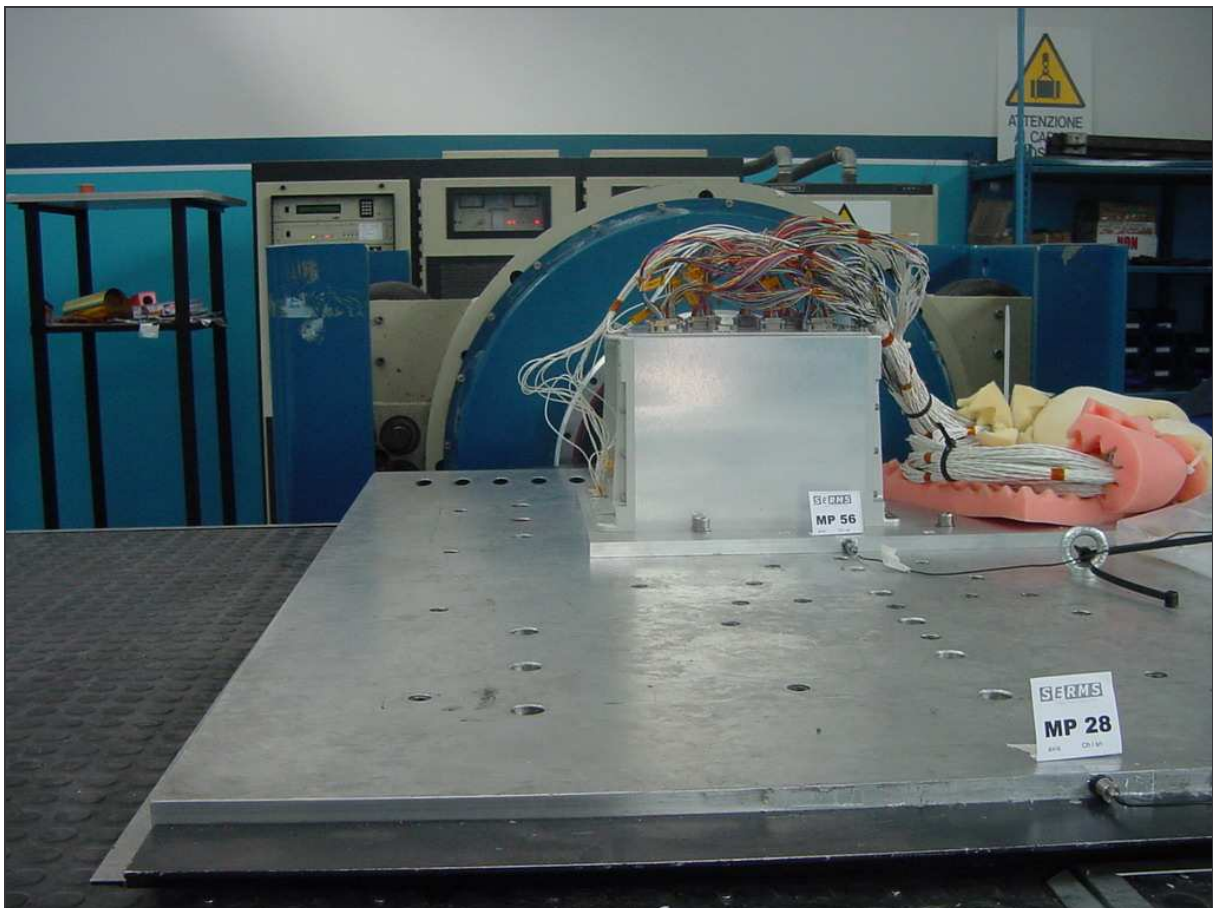
The general view of the test setup for the Y-axis is shown in figure 2. For the Y-axis sub-test the **DUT** has been mounted on a fixture matching the Y-axis of the DUT with the slip table axis, as shown below. Many sensors (channels or CH) have been used during this sub-test. They were fixed on the DUT by cyanoacrylic glue.

**FIGURE 2: Y-Axis: test set-up.**

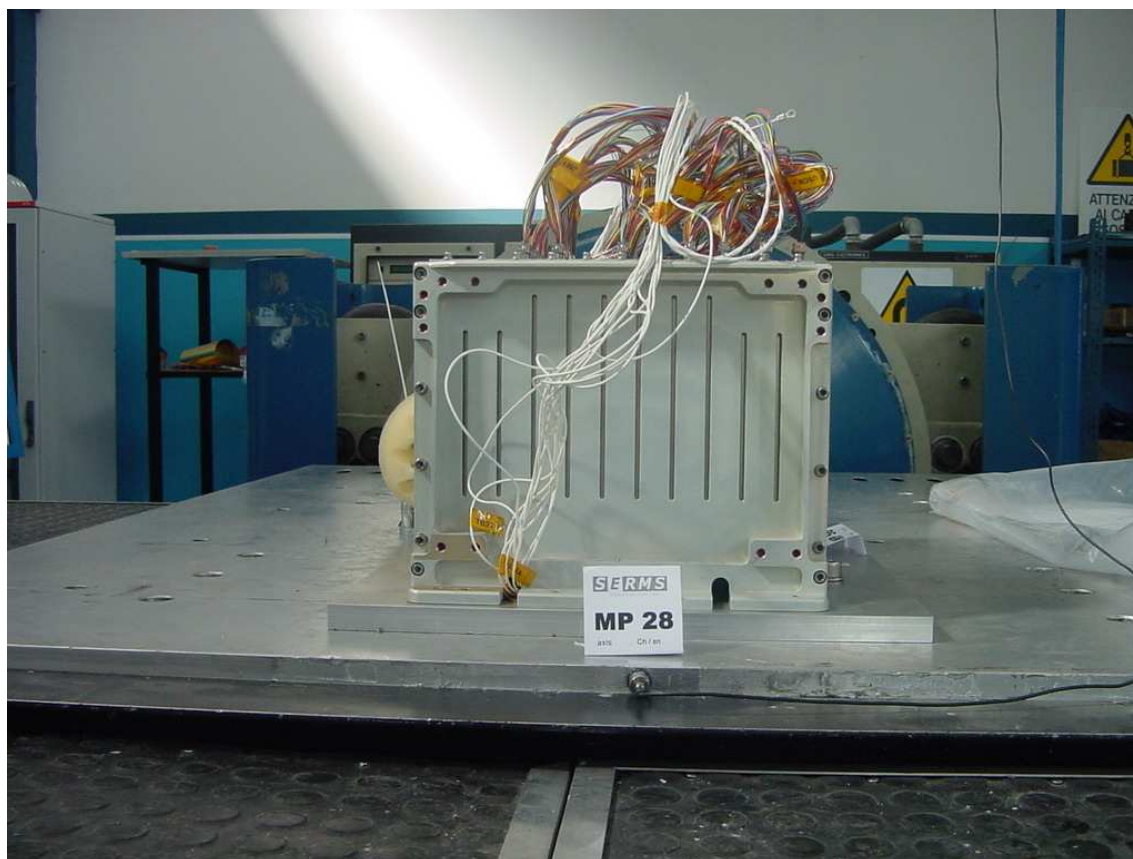
The general view of the test setup for the X-axis is shown in figure 3. For the X-axis sub-test the **DUT** has been mounted over the fixture matching the X-axis of the DUT with the slip table axis, as shown below. Many sensors (channels or CH) have been used during this sub-test. They were fixed on the DUT by cyanoacrylic glue.

FIGURE 3: X-axis test set-up.

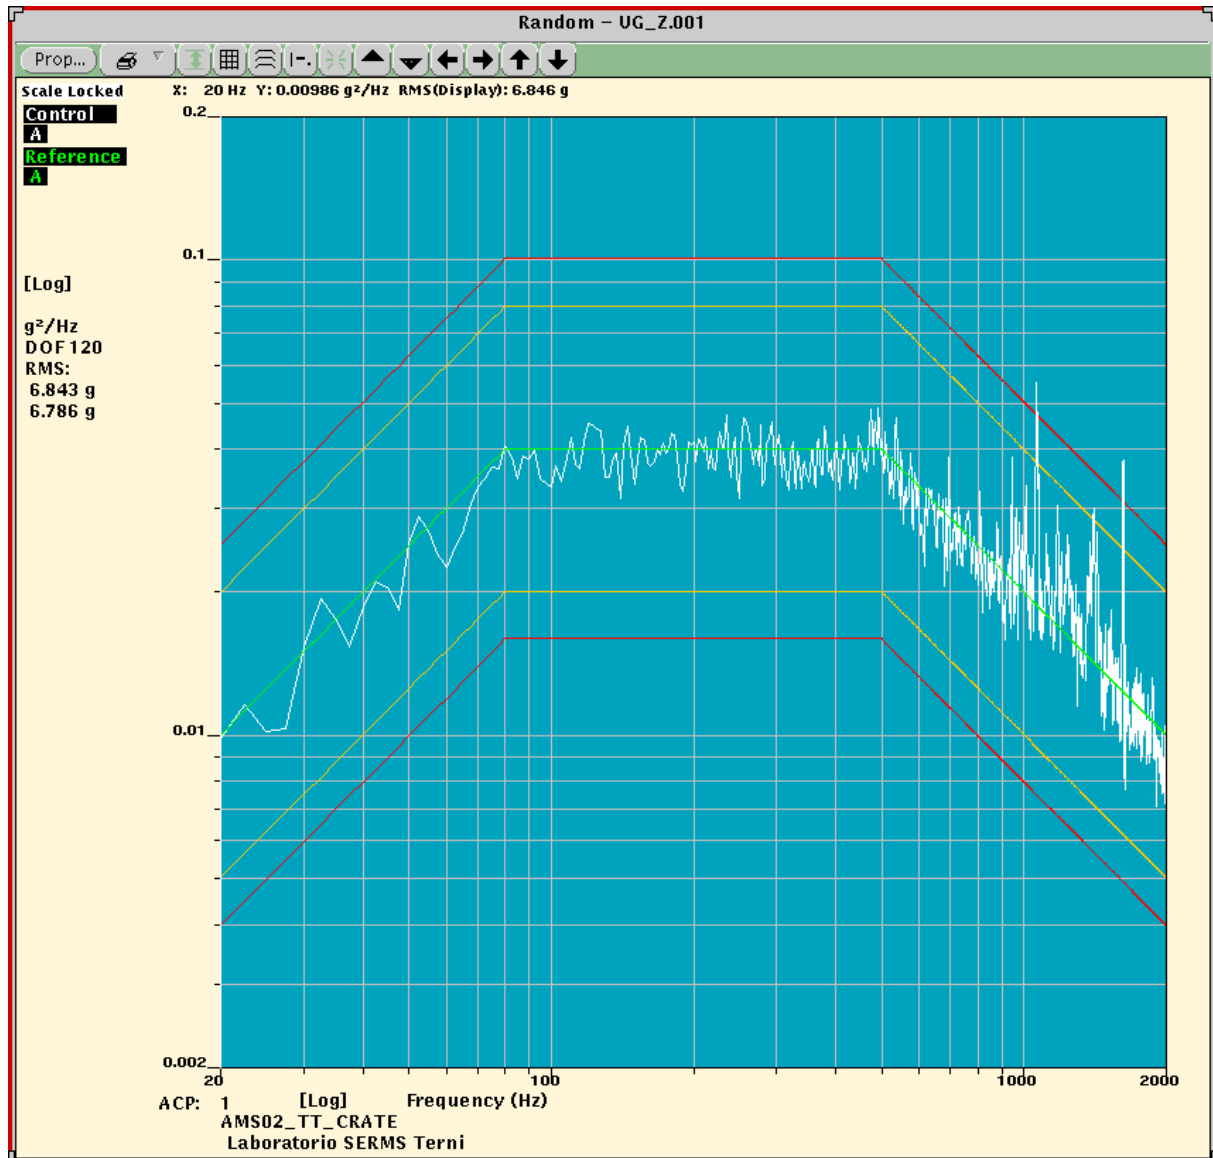
FIGURE 4: Z-AXIS random.

All Axes	20 Hz	0.01 g <sup>2</sup> /Hz
	20-80 Hz	+3 dB/Octave
	80-500 Hz	0.04 g <sup>2</sup> /Hz
	500-2000 Hz	-3 dB/Octave
	2000 Hz	0.01 g <sup>2</sup> /Hz
Overall = 6.8 Grms

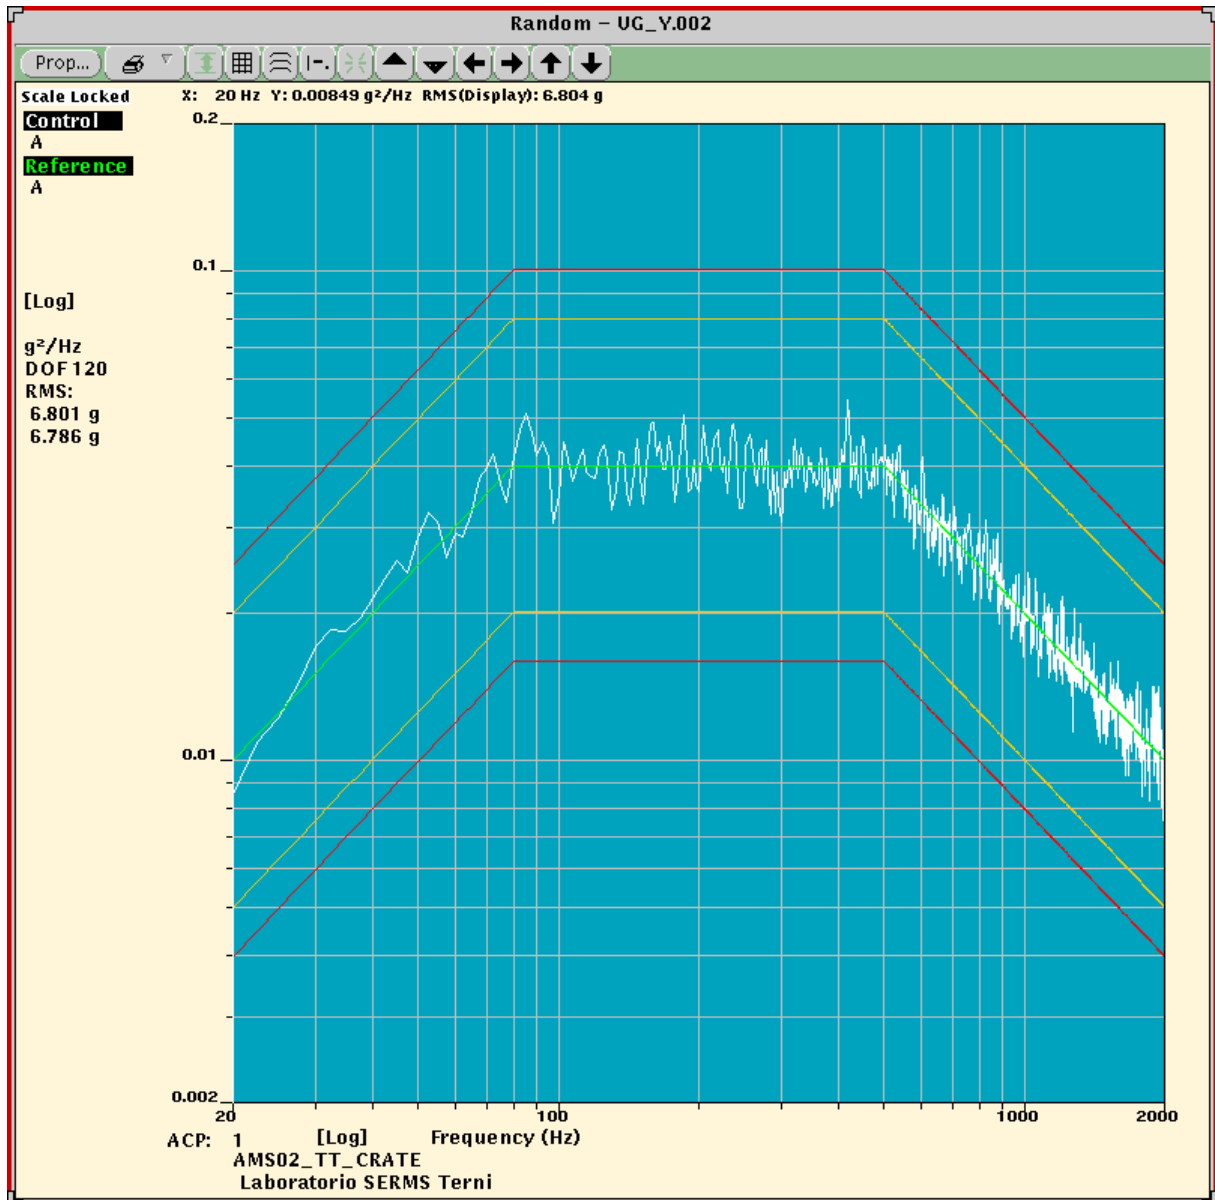
FIGURE 5: Y-AXIS random.

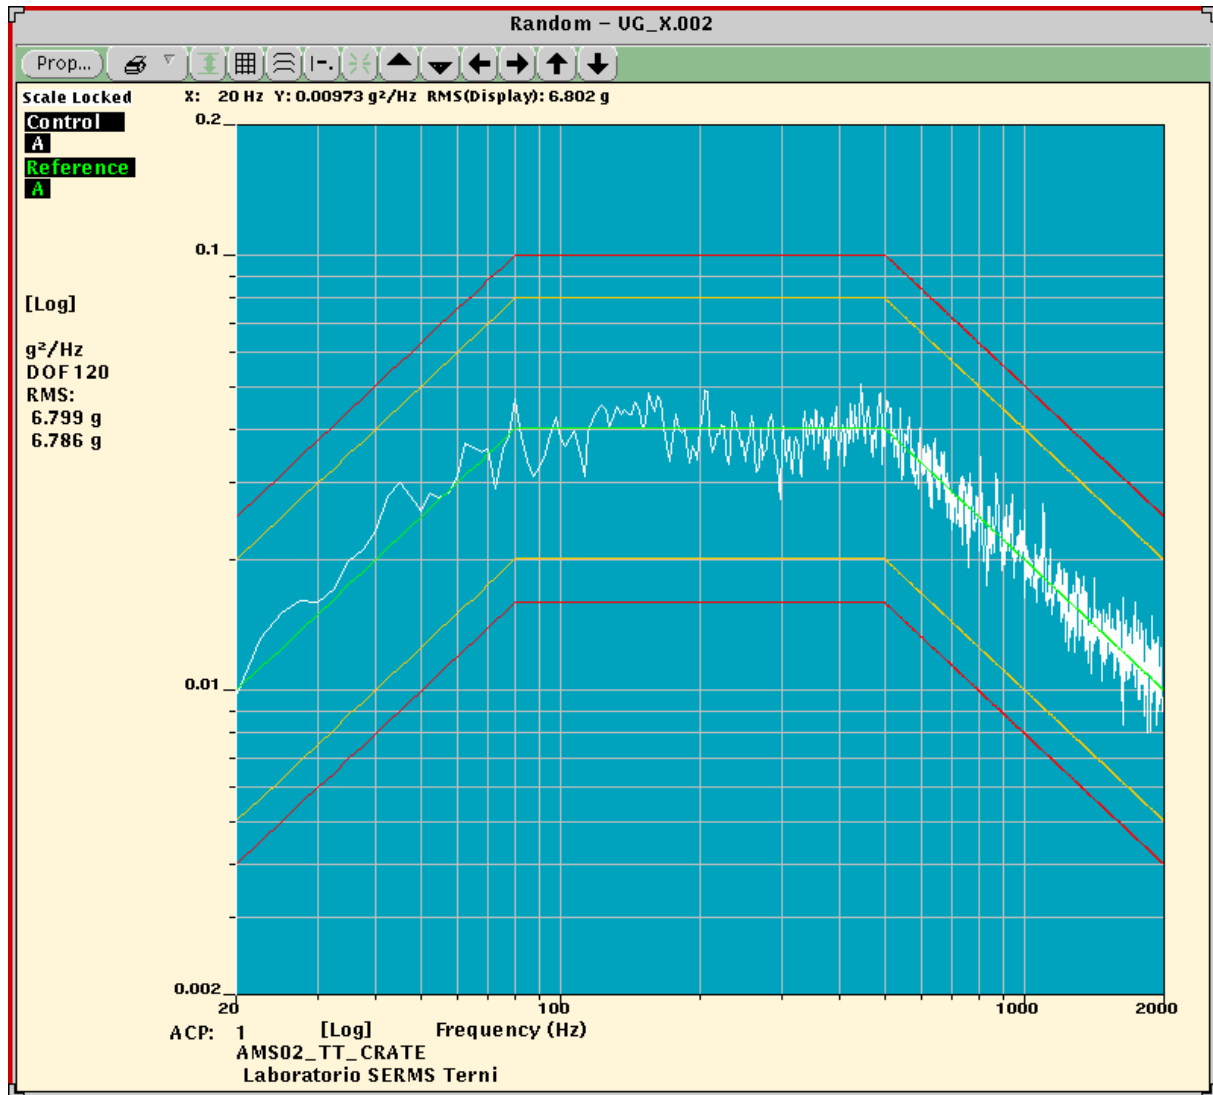
FIGURE 6: X-AXIS random.
